# Description of Advanced Adjustments

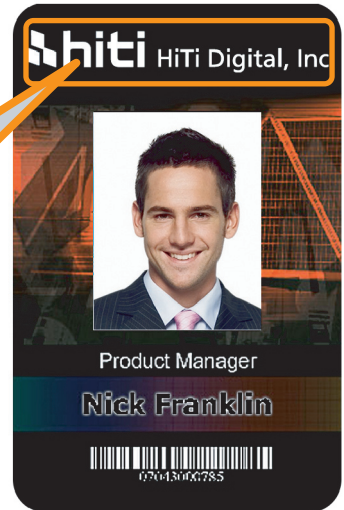
When YMC Feather-type Wrinkle appears in these areas (front or back side)

YMC Feather-type wrinkle may be caused by motor speed is too fast in supply side. Ribbon tension can be changed by adjusting motor speed. By doing so, it keeps the motor speed correctly in supply side during printing.

Slow down the motor speed on supply side (new ribbon)

In this case, it is suggested to reduce the value by 2~3 units when applying method #2

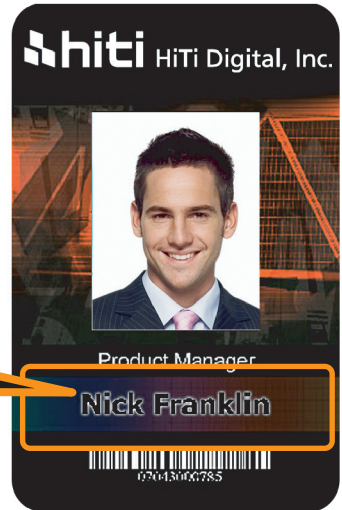
When water ripple appears in these areas  
(front or back side)

Water ripple may be caused by motor speed is too fast in supply side. Ribbon tension can be changed by adjusting motor speed. By doing so, it keeps the motor speed correctly in supply side during printing.

Slow down the motor speed on supply side  
(new ribbon)

In this case, it is suggested to reduce the value by 2~3 units when applying method #2

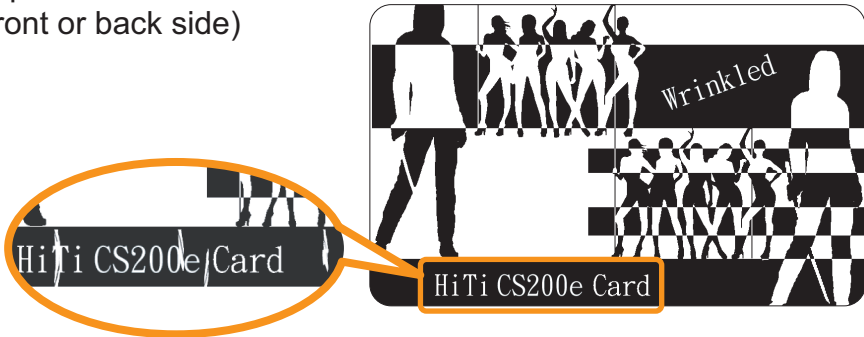
When Resin K Wrinkle appears in these areas  
(front or back side)

Resin K Wrinkle may be caused by motor speed is too fast in supply side. Ribbon tension can be changed by adjusting motor speed. By doing so, it keeps the motor speed correctly in supply side during printing.

Slow down the motor speed on supply side  
(new ribbon)

In this case, it is suggested to reduce the value by 2~3 units when applying method #2
